AFWAL-TR-88-4047

Dec 88

19. ABSTRACT (Continue on reverse if necessary and identify by block number)				
<p>This program sought basic information about the behavior of coated superalloys versus strain-temperature history in high-temperature, thermal-mechanical exposure. The test plan was based on the observation that test cycle shape strongly impacts the thermal-mechanical-fatigue (TMF) behavior. We found that increasing T_{max} of the Type 1 cycle from 1900 to 2100°F shortened the initiation period for TMF cracking and reduced cycles to specimen failure by about 30 to 50 percent. A more radical change in cycle shape, namely a four-sided shaped cycle, was less mechanically damaging (a factor of two) but more severely oxidizing than Type 1 cycles between the same temperature and strain limits. Cyclic speed experiments showed that crack initiation and cycles-to-failure data were not strongly sensitive to testing speed in the range of 1 to 4 cycles per minute. Lower N_f values for slow speed tests are believed to reflect crack growth in the substrate rather than coating effects. Shut-down steps and hold times at T_{max} and during cool-down from T_{max} generally decreased N_f value

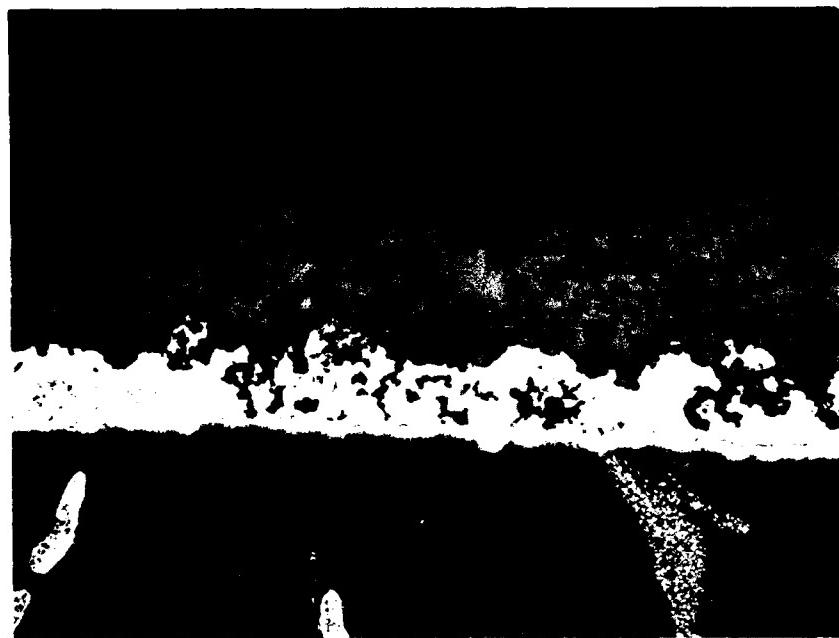
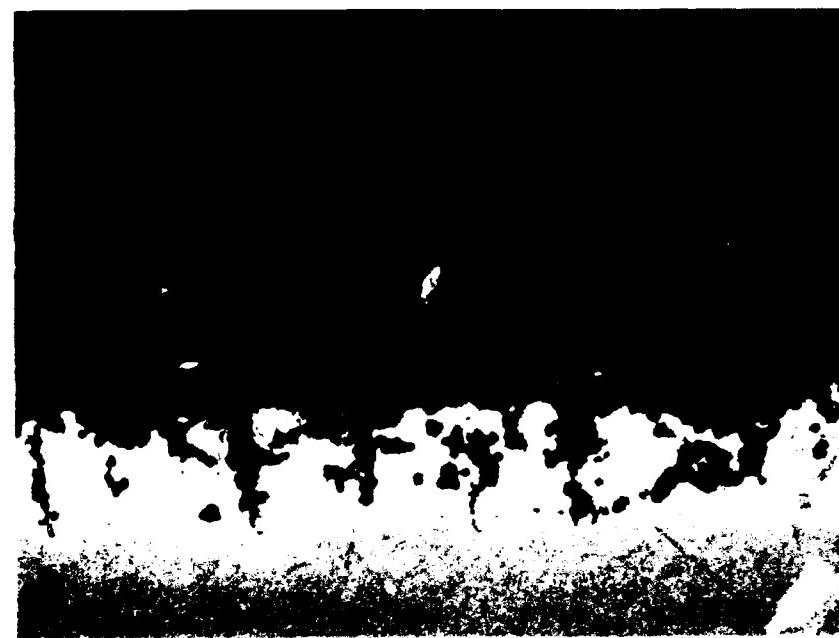
Figure 47. Bond Coat Oxidation in JTDE 2nd-Stage Vane After 4235 TAC's

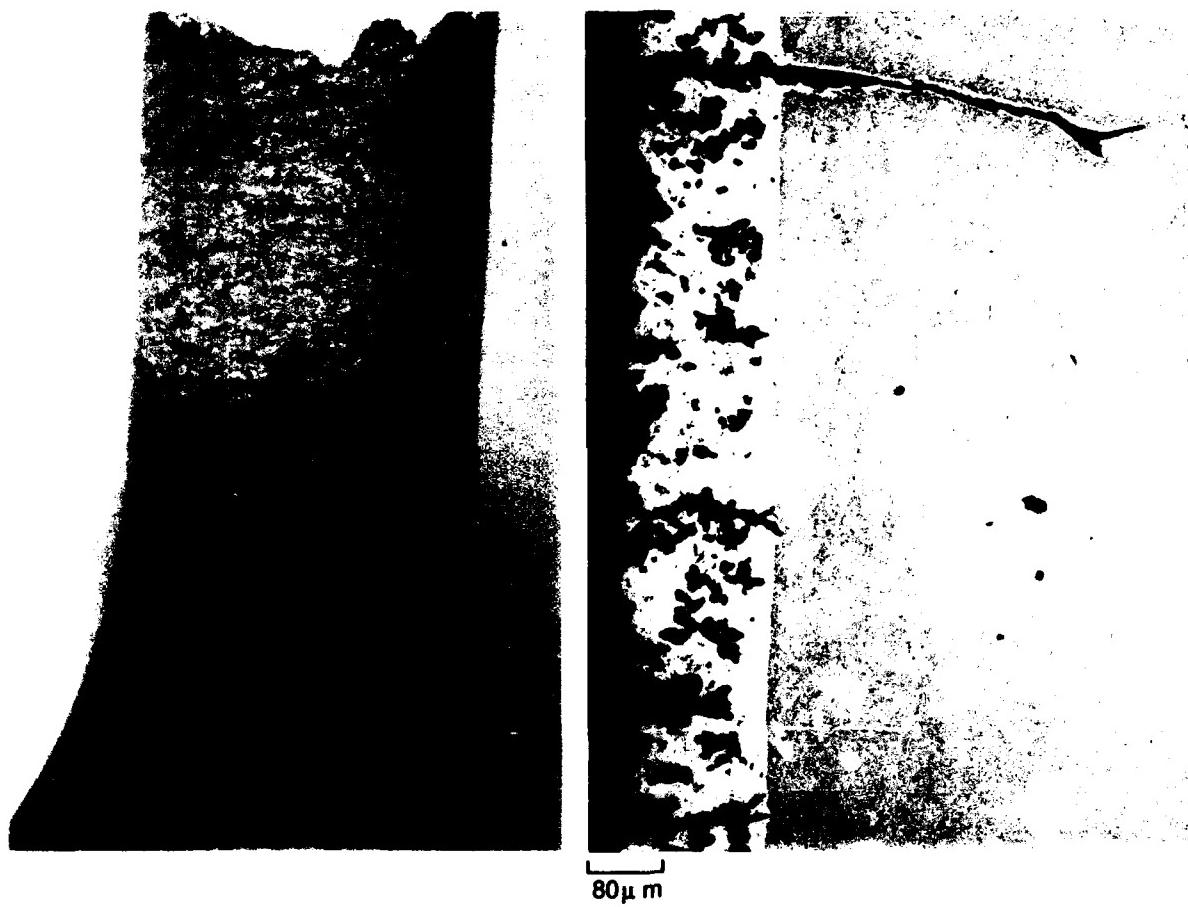
The surface condition and center gage microstructure of the 1/4 cpm sample are shown in Figure 60. The coating is heavily rumpled, and the microstructure of the hot zone is almost completely devoid of β -NiAl. As in the previously studied quad cycle specimens, however, the interdiffusion zone is thin, indicating that most of the β phase was consumed by surface connected oxidation rather than coating/substrate interdiffusion. The extent of β loss is slightly greater than at faster testing speeds, although there is no evidence that the microstructural effect significantly influenced mechanism of crack initiation/propagation in the coating.

Figure 60. Surface Condition and Longitudinal Microstructure of Quad Cycle (-0.1%/800°F, -0.6%/1800°F, -0.3%/2000°F, +0.1%/1280°F) TMF Specimen (1/4 Cycle per Minute, Cycles to Failure = 10,579)

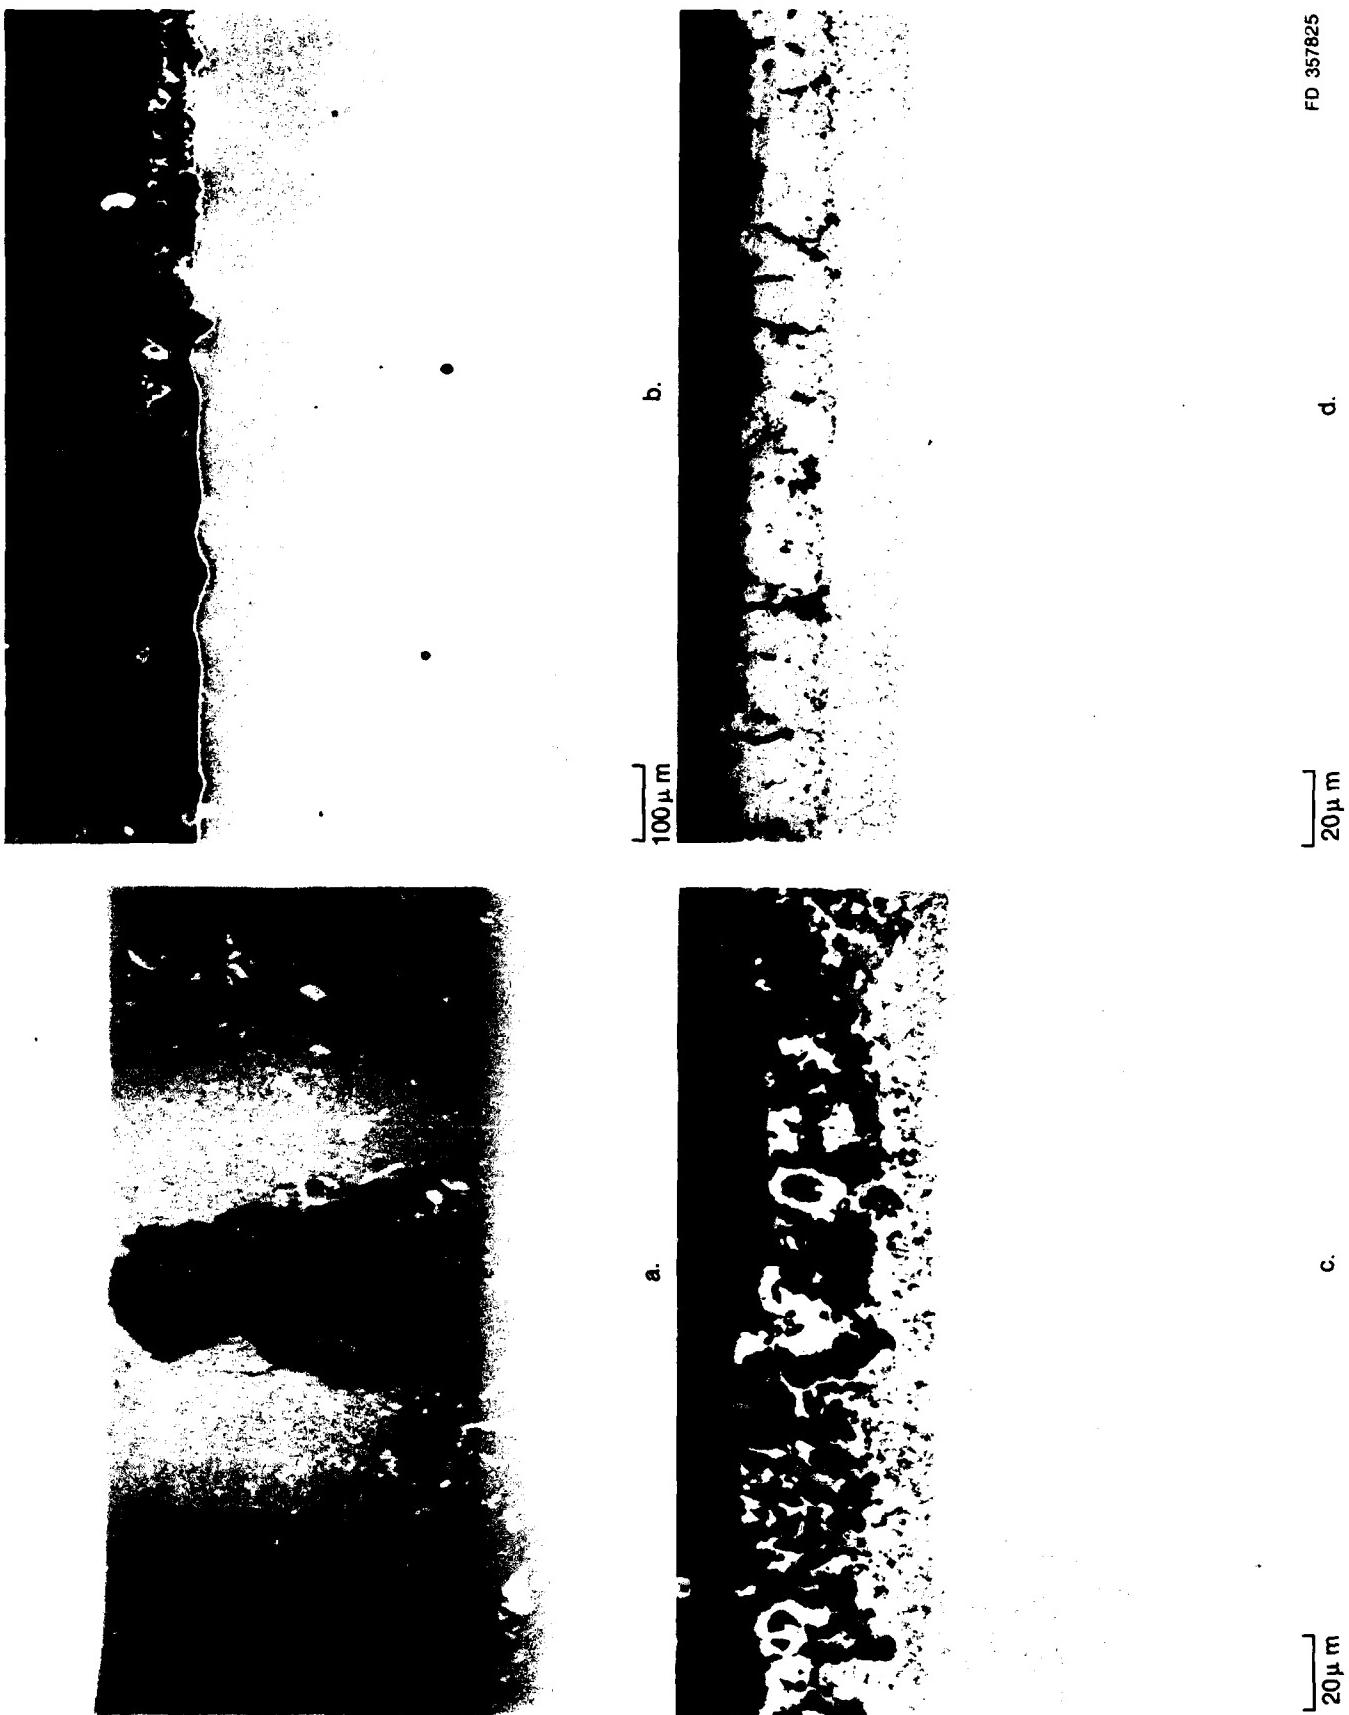
Figure 62. Surface Condition and Gage Section Microstructures of Quad Cycle (-0.1%/800°F, -0.6%/1800°F, -0.3%/2000°F, +0.1%/1280°F) TMF Specimen of Gas Phase Aluminized PWA 1480 (Exposure Time = 9881 Cycles)

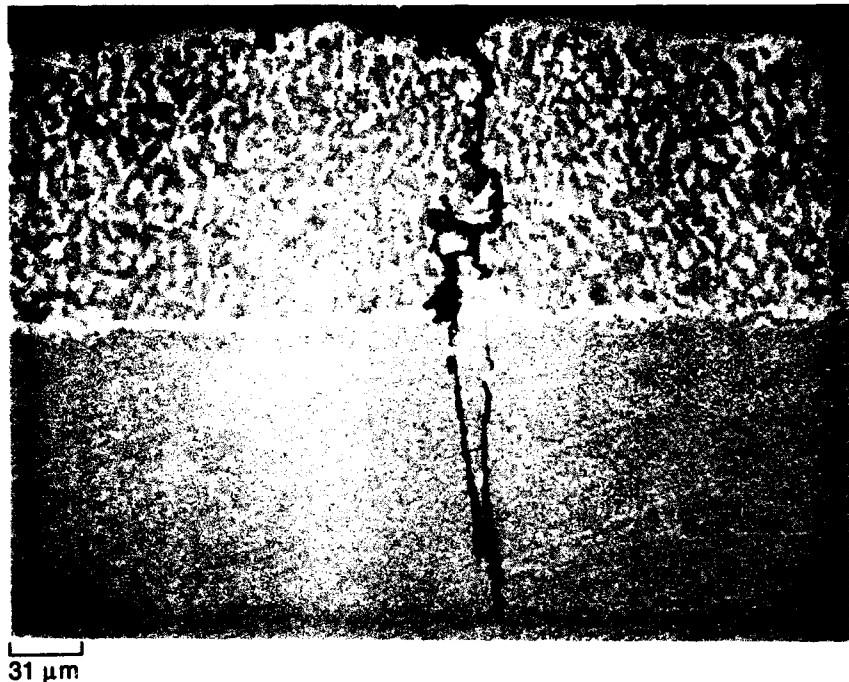
FD 357829

A sample of PWA 1480/PWA 276 NiCoCrAlY exposed to the quad/shutdown (from 800°F) cycle failed in 8,967 cycles. Heavy rumpling, initiation of secondary cracks at the valley of the ripples, and preferential β -phase oxidation in the vicinity of the cracks were discernable in the microstructure (Figure 68). Microstructural degradation of the two-phase NiCoCrAlY was considerably less than that of PWA 275 in the same cycle, although oxidation effects may have influenced coating durability in that the fracture surface of the coating and some of the secondary cracks appeared to follow the γ - β interface, (i.e., the path of preferential oxidation).

Figure 68. Hot Section Microstructure of Quad Cycle/Shutdown TMF Specimen of PWA 1480/PWA 276 NiCoCrAlY (Cycles to Failure = 8967)

The N_f value for the overlay coating (about 9,000 vs 14,000 for the baseline quad) suggests the shutdown aggravates the TMF process. The mechanism of degradation of the 275 aluminide, however, is still determined by the shape of the quad, and oxidized grain boundaries apparently do not propagate into the substrate in spite of the increased tensile loads in the shutdown step.

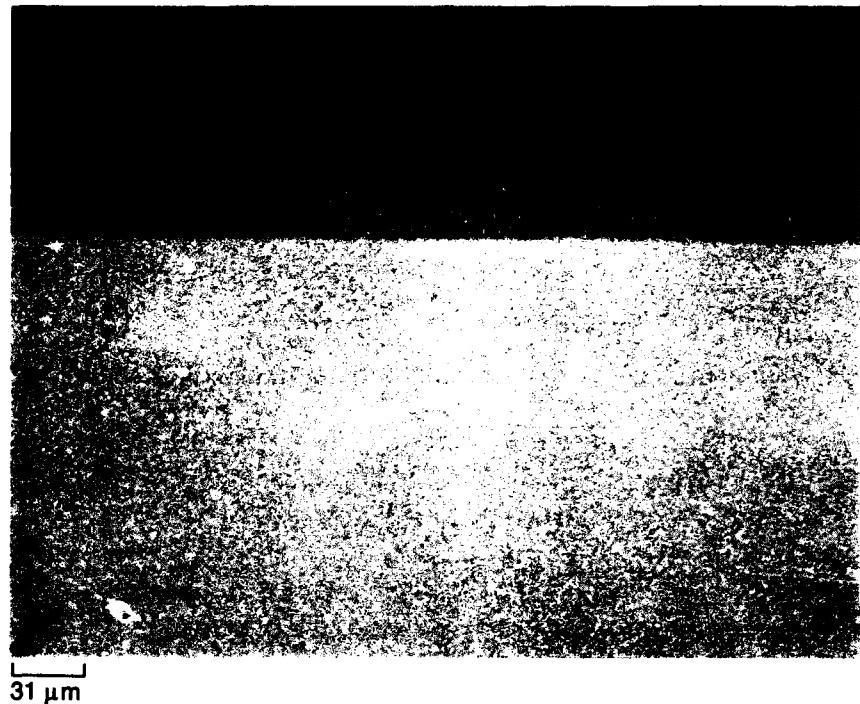
FD 357830

Lastly, to examine the initial stages of microstructural degradation, a shutdown sample was run for 4000 cycles on both PWA 275 aluminide and PWA 276 NiCoCrAlY coatings. No cracks were detected on visual inspection of the aluminide, although substantial grain boundary oxidation was evident in the cross section, and the initial stages of eventual undercutting and spallation of the β -NiAl layer were obvious (Figure 69). The PWA 276 sample was heavily rumpled, and TMF cracks were initiating at some of the ripples (Figure 70).

Figure 69. Hot Section Microstructure of Quad Cycle/Shutdown TMF Specimen of PWA 1480/PWA 275 Aluminide (Exposure Time = 4000 Cycles)

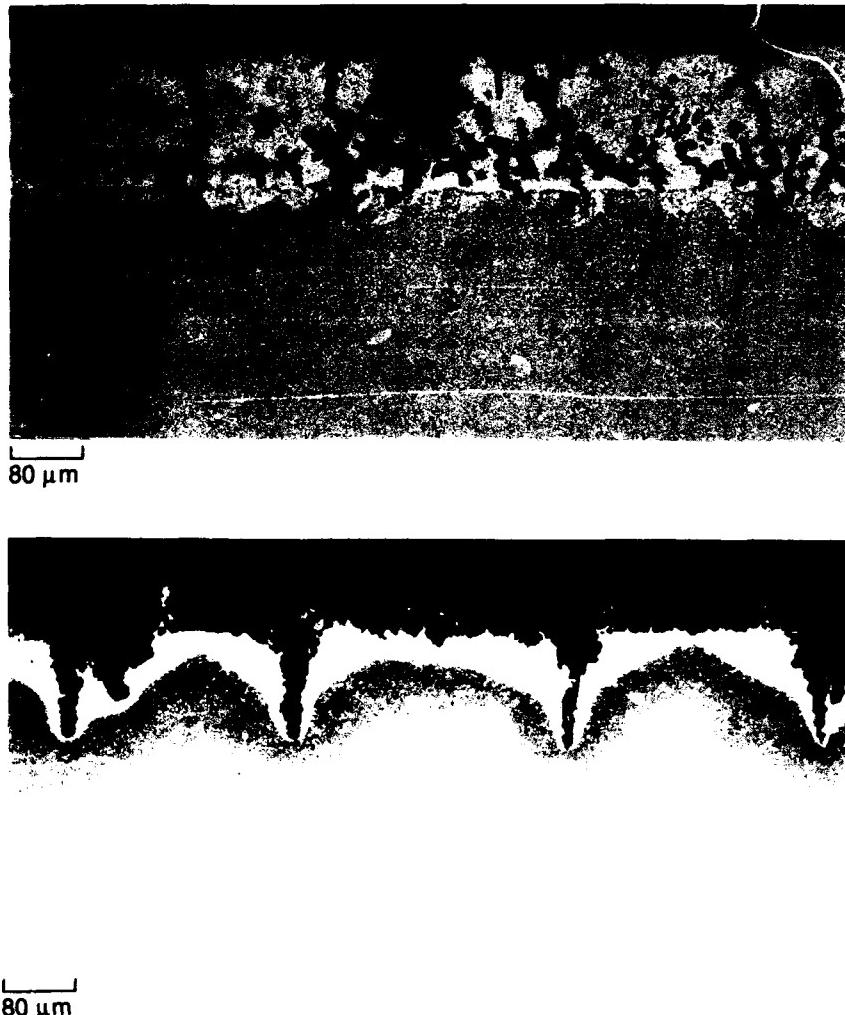
Figure 71. Center Gage Microstructure of Quad Cycle TMF Specimen of PWA 1480/PWA 276 NiCoCrAlY (2-Minute Isothermal Hold at 1800°F on Cool-Down Step, Cycles to Failure = 10,520)

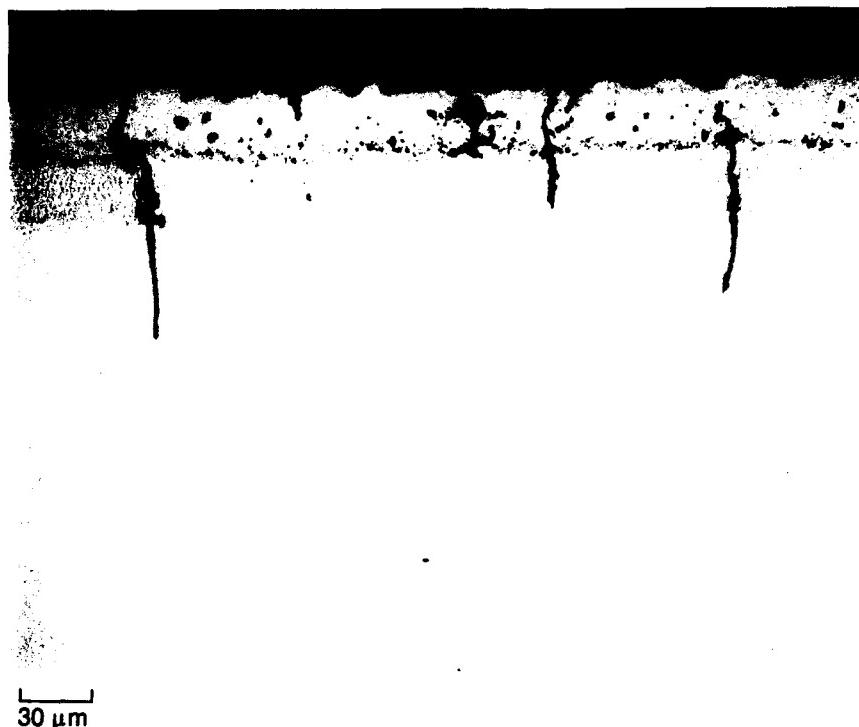
FD 357833

Microstructural degradation of the coating on the short-time sample was negligible; after 8,236 cycles there was metallographic evidence of the strain-induced oxidation morphology previously associated with the original, wide quad cycle (Figure 75).

Figure 75. Typical Gage Section Microstructure of Modified Quad Cycle (+0.10%/800°F, -0.50%/1900°F, -0.45%/2000°F, +0.20%/900°F) TMF Specimen of PWA 1480/PWA275 Aluminide (Cycles to Failure = 8,326 at 4 cpm)

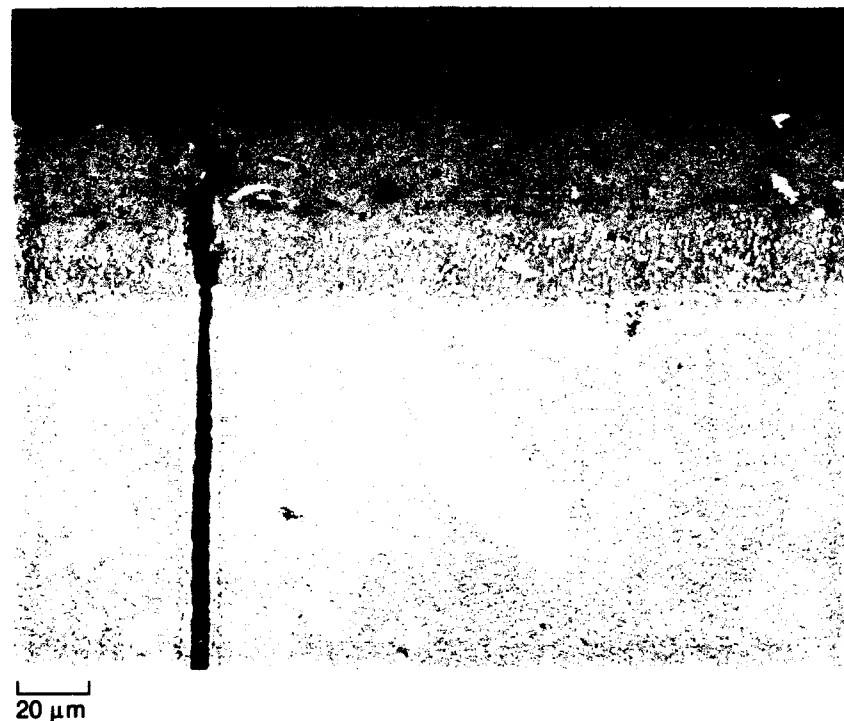
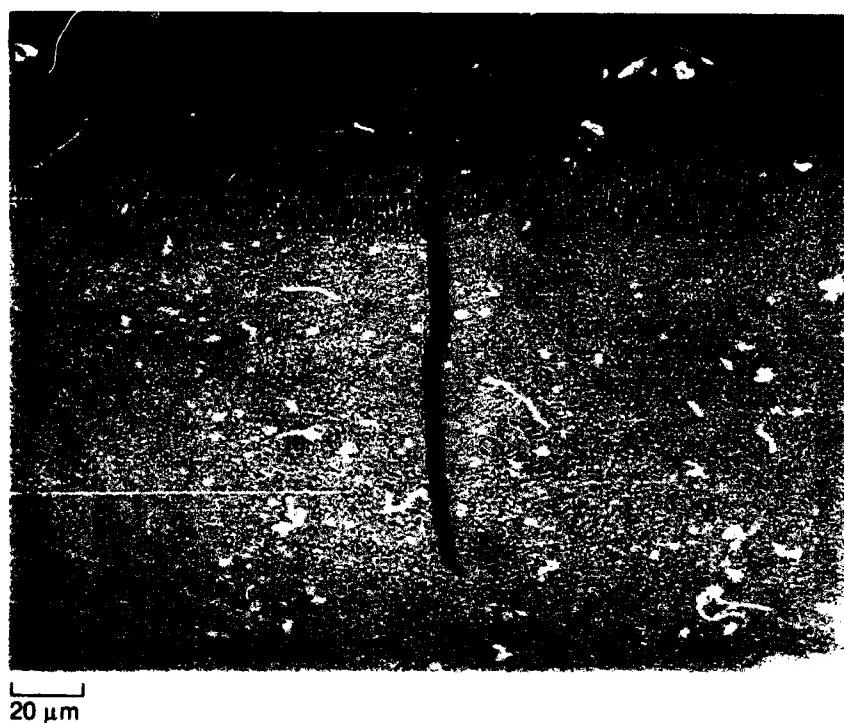
FD 357834

Figure 76 compares the typical gage section microstructure of the Type 1 sample with the quad 5B which failed in approximately the same number of cycles. Selected areas would support the argument that grain boundary oxidation is more prevalent in the quad, although the difference is not striking.

Figure 76. Microstructure of Narrow Quad (Top) Versus Type 1 TMF Sample With Same Temperature Limits and Strain Range (N_f for Narrow Quad = 4971 Cycles; for Type 1, 4954 Cycles)

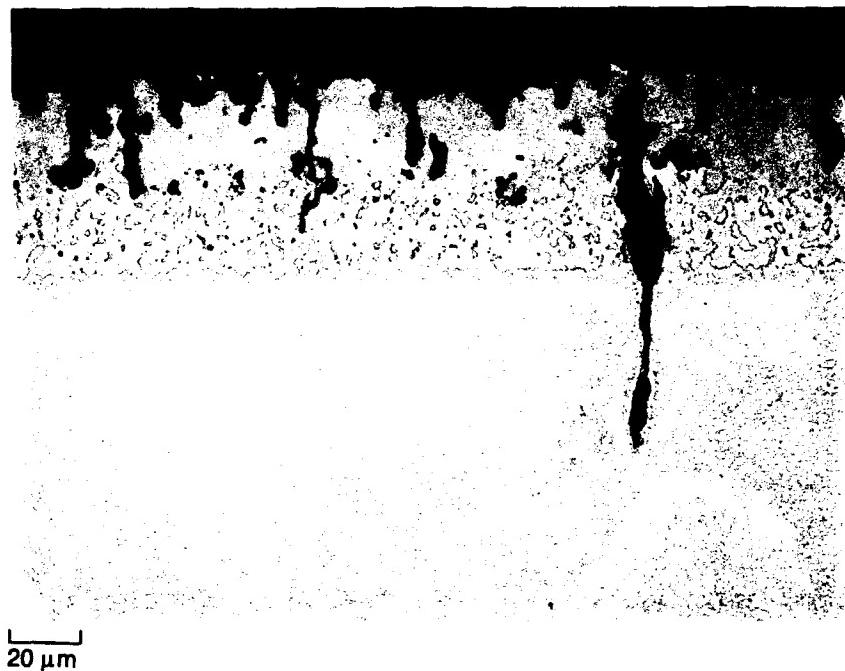
FD 357835

Grain boundary oxidation in one of the wider quad samples (7B) is shown in Figure 77. The attack is not nearly as severe as in the original quad, but the nature of the grain boundary oxidation appears similar.

Figure 77. Microstructure of Modified Quad (7B in Table 3) TMF Sample ($N_f = 8,418$)

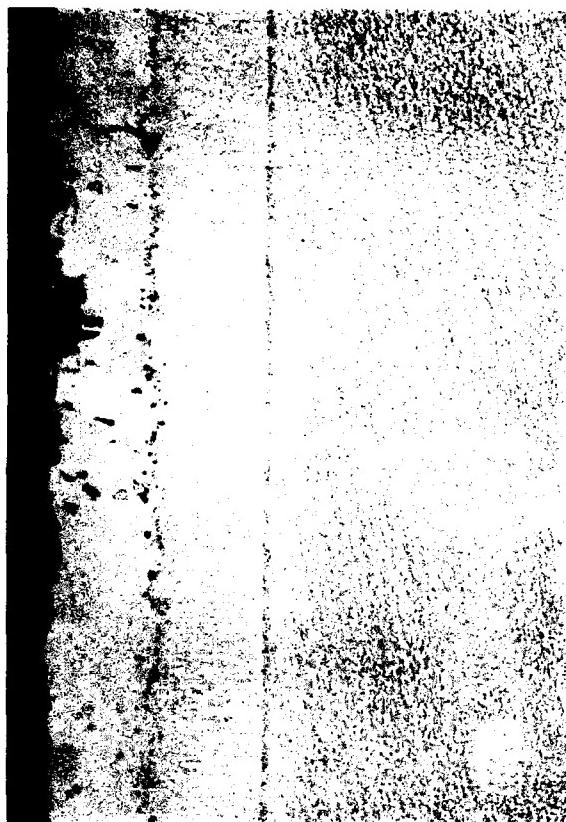
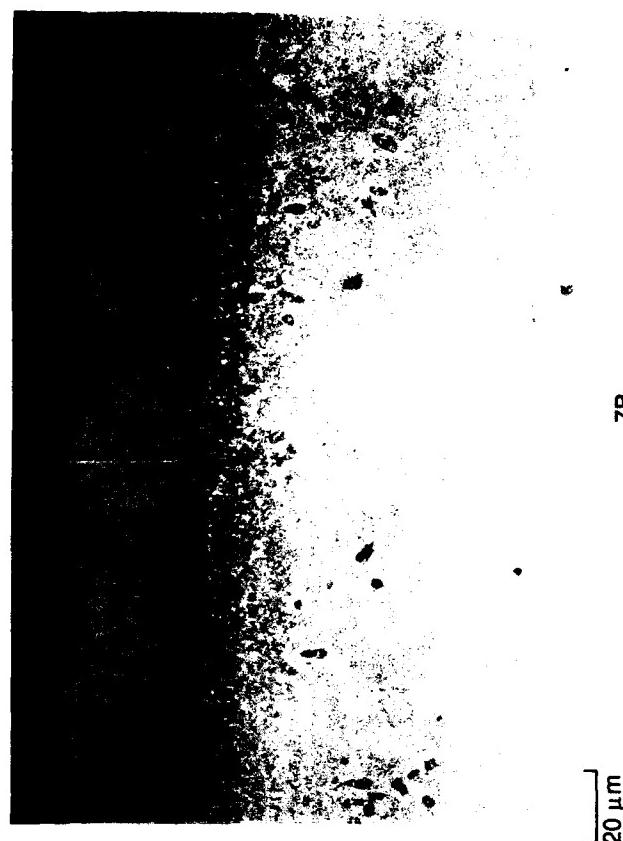
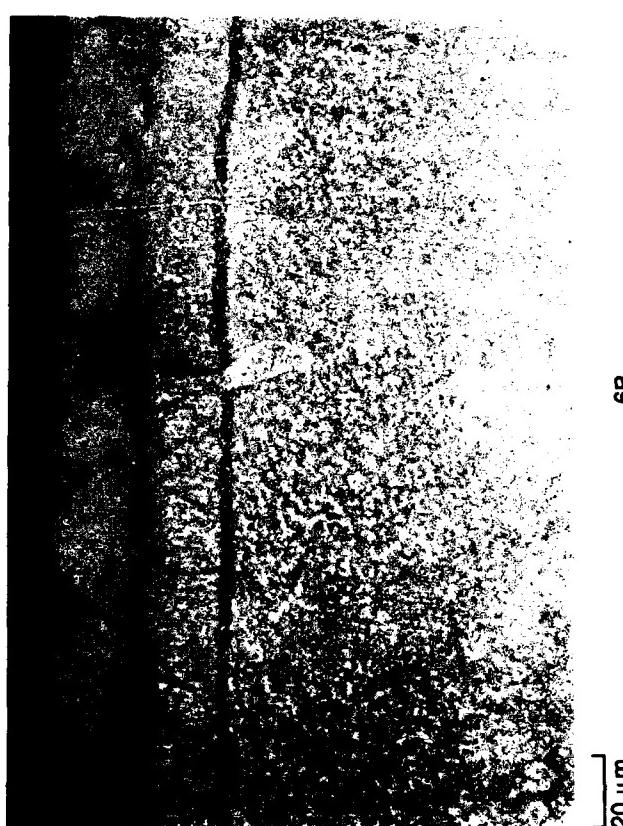
Figure 78. Center Gage Microstructure of Quad Cycle TMF Specimens (4000 cycles at 4 cpm)

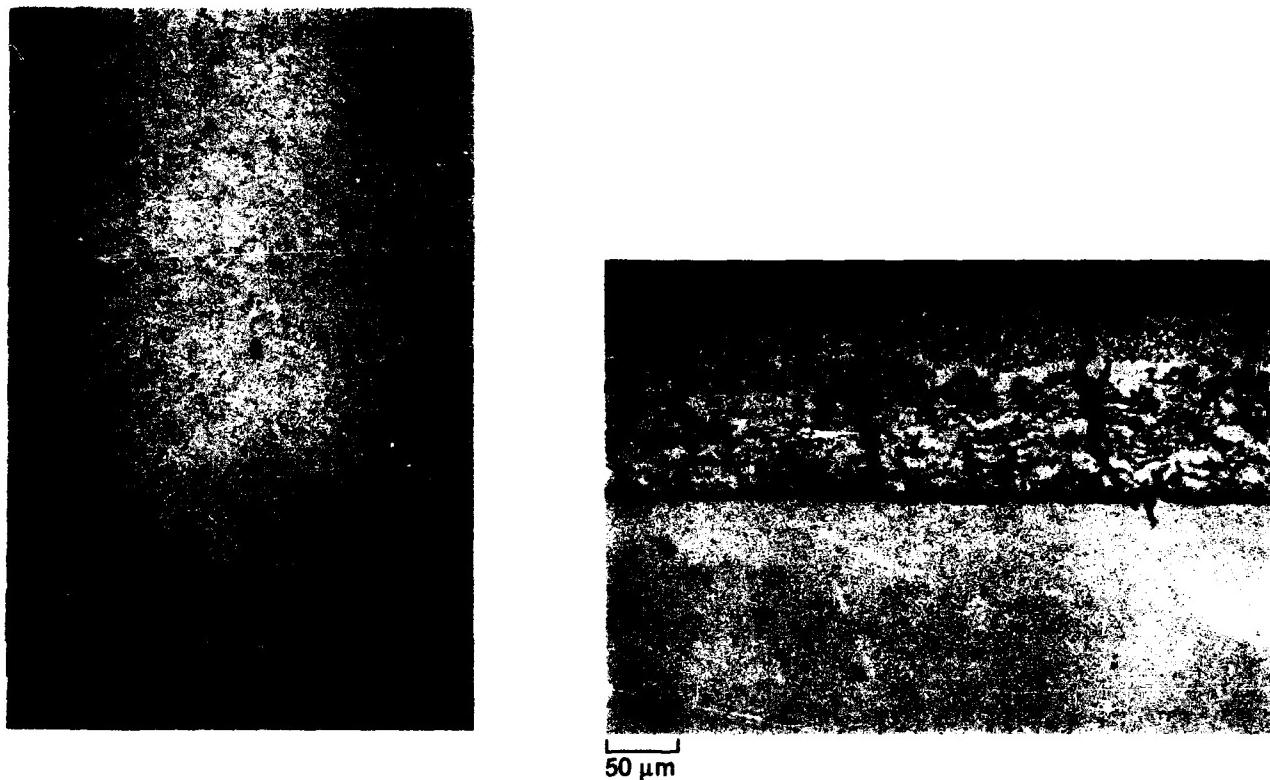
FD 357837

Cycles to initiation/failure data from this task are not interpretable, due primarily to coating adherence problems. Coating separation was often evident from nonuniform heating and cooling during the TMF cycle, and this problem precluded effective temperature control during test as well as meaningful post-test metallography.

Figure 80 for example, shows a type 1 specimen which was stopped after 900 cycles because of visual observation of nonuniform temperature cycling (the discontinuity at the coating/substrate interface interferes with heat flow). Numerous cracks already extend through the coating. Indeed the cracks are stopped when the coating separates from the base alloy, but such a situation is unlikely to be of either practical or mechanistic interest.

Figure 80. Surface Condition and Gage Section Microstructure of Strain Isolator Coating After 900 Type 1 Cycles at 0.7% Strain Range.

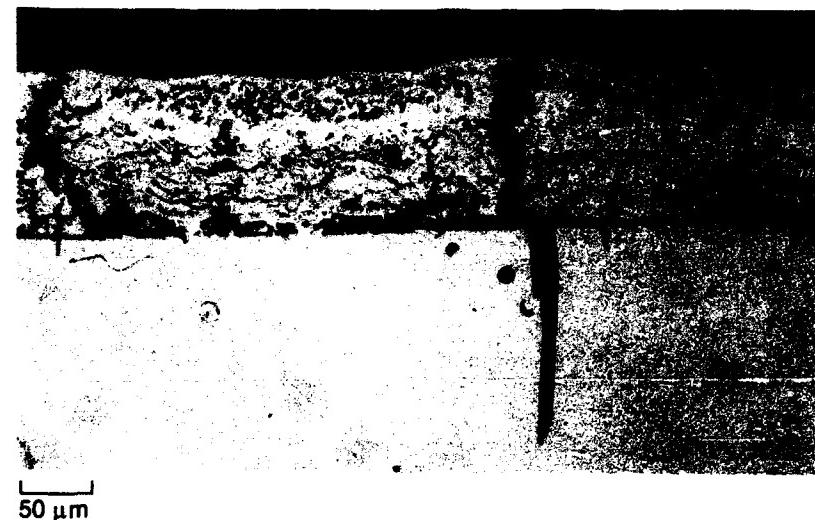
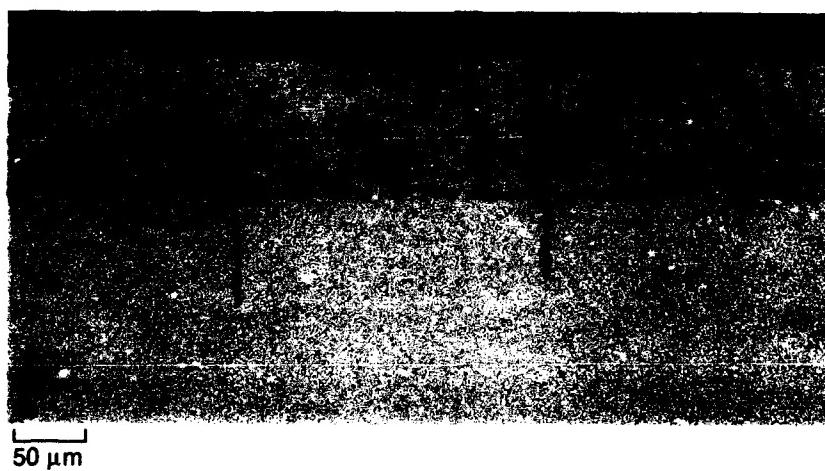
FD 357838

A specimen run to failure in a Type 1 test is illustrated in Figure 81. Many cracks are stopped because of interfacial separation, but adherence in localized areas is apparently sufficient for many others to propagate into the substrate.

Figure 81. Typical Microstructure of Two-Layer Strain Isolator Coating (Type 1 TMF Cycle, 800-2000°F, $N_f = 3179$ at 2 cpm)
